BEAVER RIVER. HERKIMER COUNTY

STILLWATER RESERVOIR DAM

PHASE I INSPECTION REPORT NATIONAL DAM SAFETY PROGRAM

NY 00316

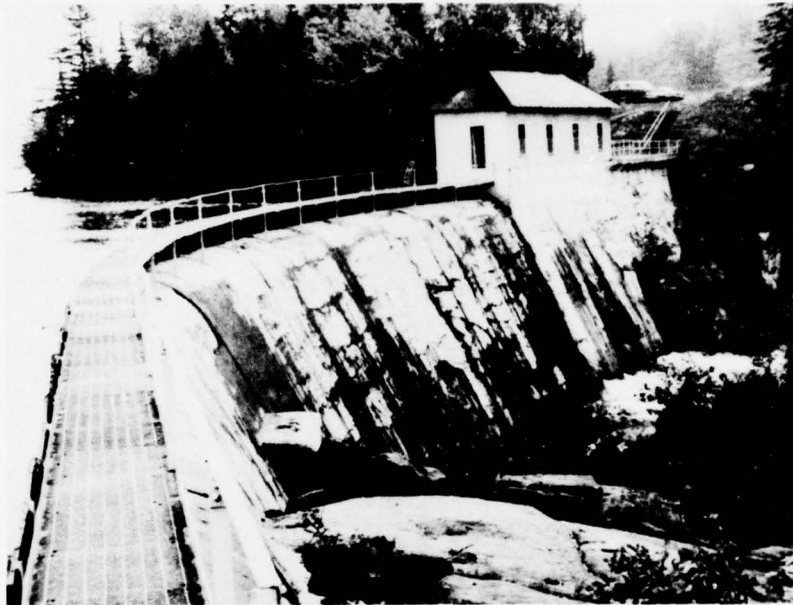
CONCRETE SPILLWAY AND GATE HOUSE

The downstream face of the non-overflow section shows signs of deterioration. A protective surface treatment (gunite) which was applied to the structure has weathered and cracked. Some spalling of the gunite was noted in the downstream slope of the non-overflow section.

The downstream face of the spillway has also been surfaced with a protective material. A much more significant deterioration of the material than observed on the non-overflow section was evident. In areas where the material had dislodged from the structure, spalled concrete was again noted. No seepage was observed in the toe area of the gravity section.

3. Remove and replace the deteriorated concrete surface protection material as required.

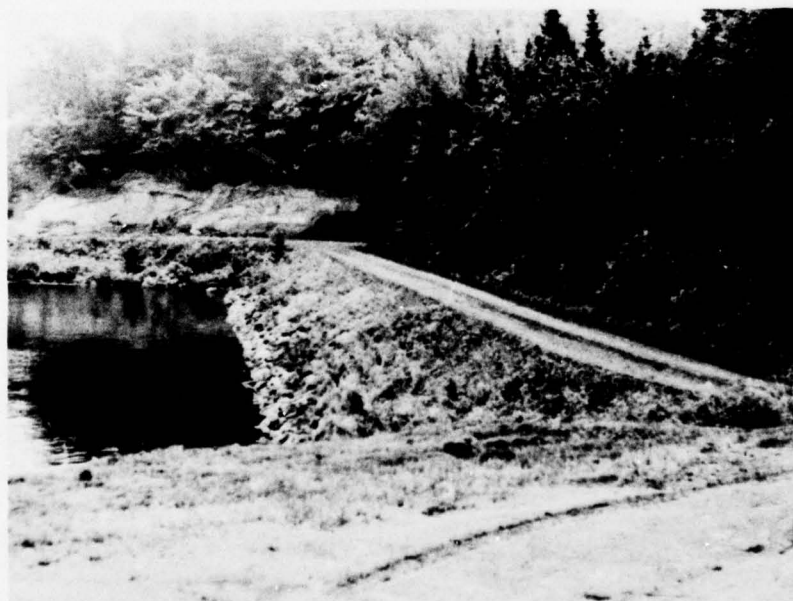
SOUTH DAM LOOKING SOUTH

The downstream slope of the embankment is covered with a relatively dense growth of trees and brush for its entire length. Some riprap was noted interspaced along the slope. Pools of water were observed at three locations at the toe of the downstream slope, however, no movement which would indicate flow was detected in any of the pools. The upstream slope of the embankment is surfaced with riprap consisting of semi-angular granitic type rock weighing from about 75 to 300 pounds each. The riprap protection extends about six feet above the present water level. Vegetation along this slope is limited to a few small trees and brush. The embankment appears to be straight and no noticeable indications of settlement or erosion were noted.
